**Air-Conditioning, Heating and  
Refrigeration Technology Institute**

AHRTI Report No. 9007-01

BENCHMARKING RISK BY WHOLE ROOM SCALE LEAKS AND IGNITIONS TESTING OF A2L REFRIGERANTS

UL LLC

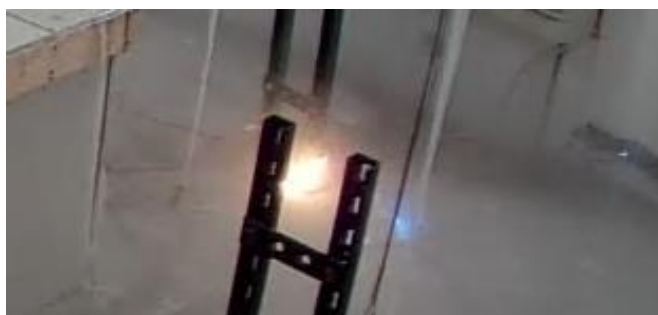
Ceiling camera view at ignition of candles and electric arcs 57 seconds after the start of discharge.

A small refrigerant flame was observed near location A. The cheesecloth was not ignited. The total flaming time for the refrigerant flame was 3 seconds.

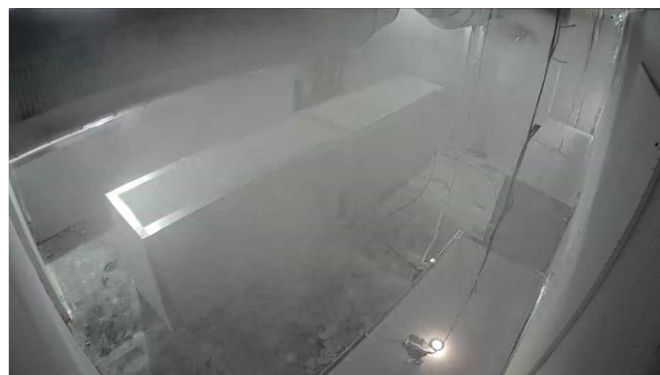
Mist exiting the supply duct at 62 seconds after the beginning of the discharge. The blower motor had been started 2 seconds prior to this frame. The candle at location D extinguished 2 seconds later.

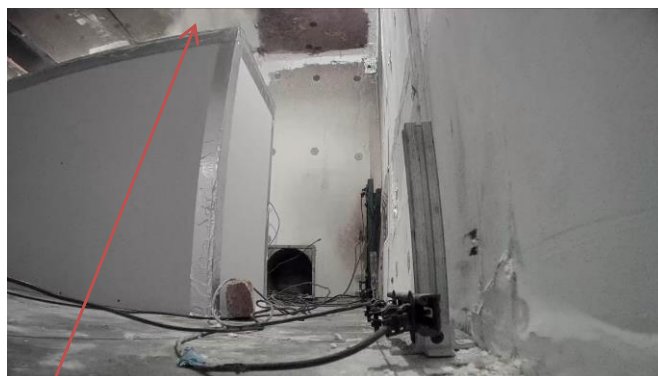
Mist exiting the supply duct at 62 seconds after the beginning of the discharge. The blower motor had been started 2 seconds prior to this frame. Flames about 1 inch in height were observed at the electric arc locations after the blower had been running for 5 seconds.

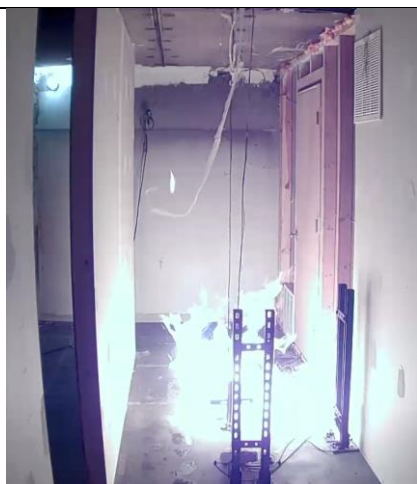
16s after refrigerant release; flame spread observed on the floor in the hallway toward the right wall.

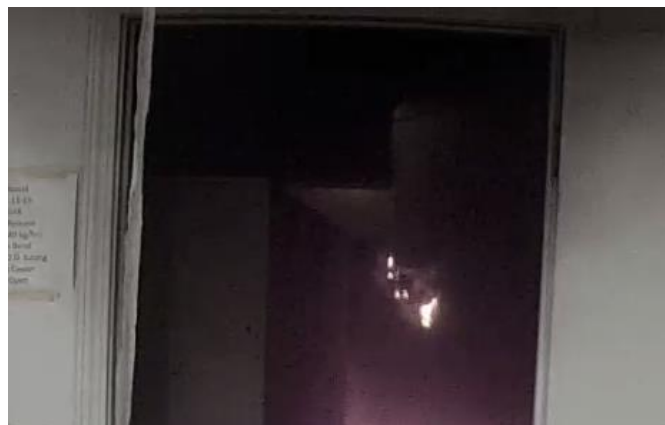
Up until 83 seconds, the fire was at the floor level. This frame shows embers from the cheesecloth floating up to the level of the unit cooler. This caused ignition at the ceiling level.

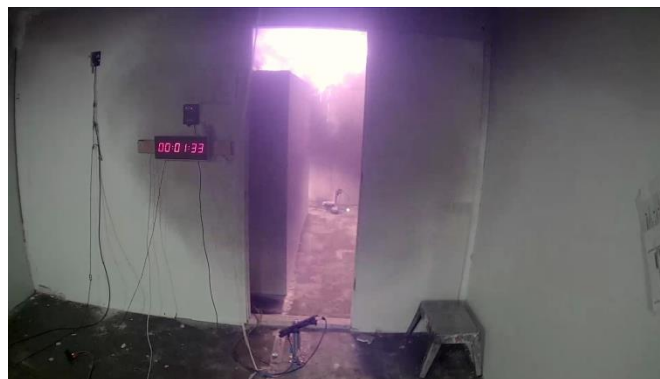
At 85 seconds, the volume around the unit cooler was fully involved in flame and the peak pressure was recorded. This frame shows the peak pressure pushing a plume of smoke out of the walk-in cooler and toward the camera. The total duration of flaming was 58 seconds.

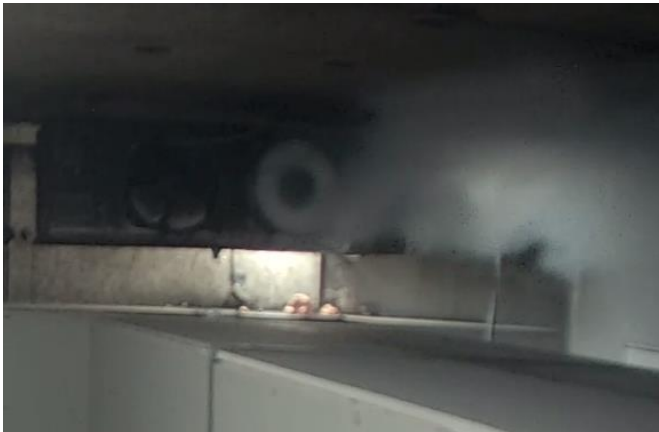
The discharge in the coil face caused the fan to rotate. Note the frost buildup on the right-hand fan blades.

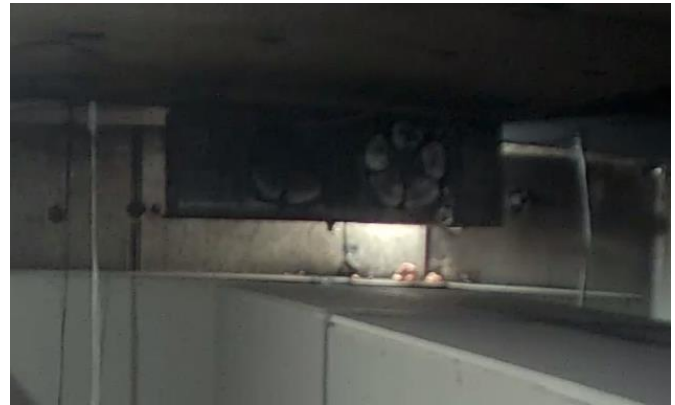
After the discharge was completed the fan stopped rotation and the frost began to melt away.
